## MAGNETIC RESONANCE IMAGING HAZARDS AND SAFETY GUIDELINES

## CRITICAL MRI SAFETY EDUCATION

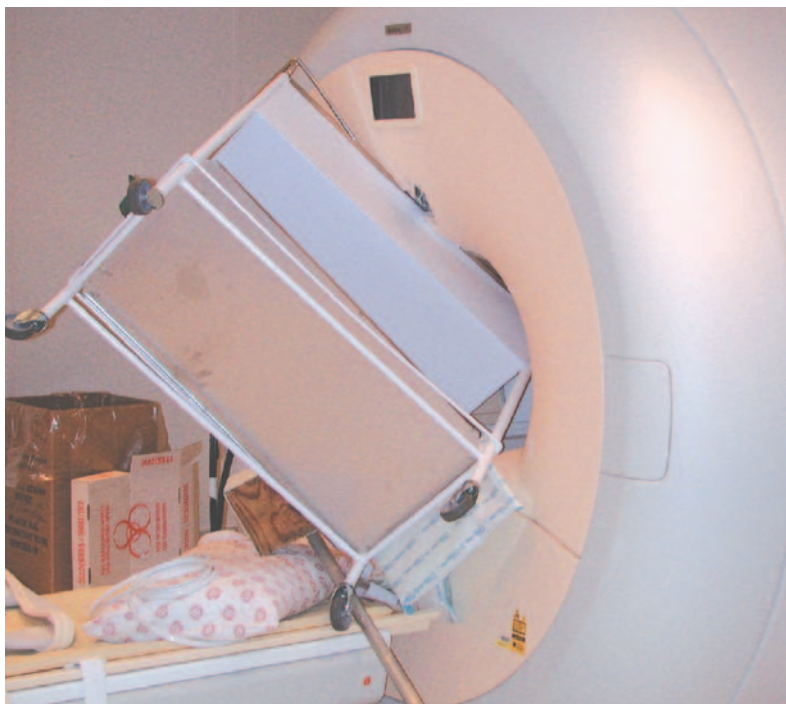
This effect is generally attendant upon ferromagnetic materials and the static field generated by an MRI system, and often manifests as the missile effect, which can involve non-compatible objects, such as wheel chairs, transport stretchers, file cabinets, electrical equipment and tools, powered and unpowered hand tools, stethoscopes, medical equipment carts, medical equipment (pulse oximeters, EKG, IV pumps, etc), communications devices, physician beepers, and miscellaneous (and often forgotten) patient and visitor objects that include hairpins, paper clips and pens.

A hairpin or paper clip within the 5-10 gauss line range could reach a velocity of 40 mph and will be attracted to the center of the MRI generated field (*x, y and z axis*) where the lines of force are equal.

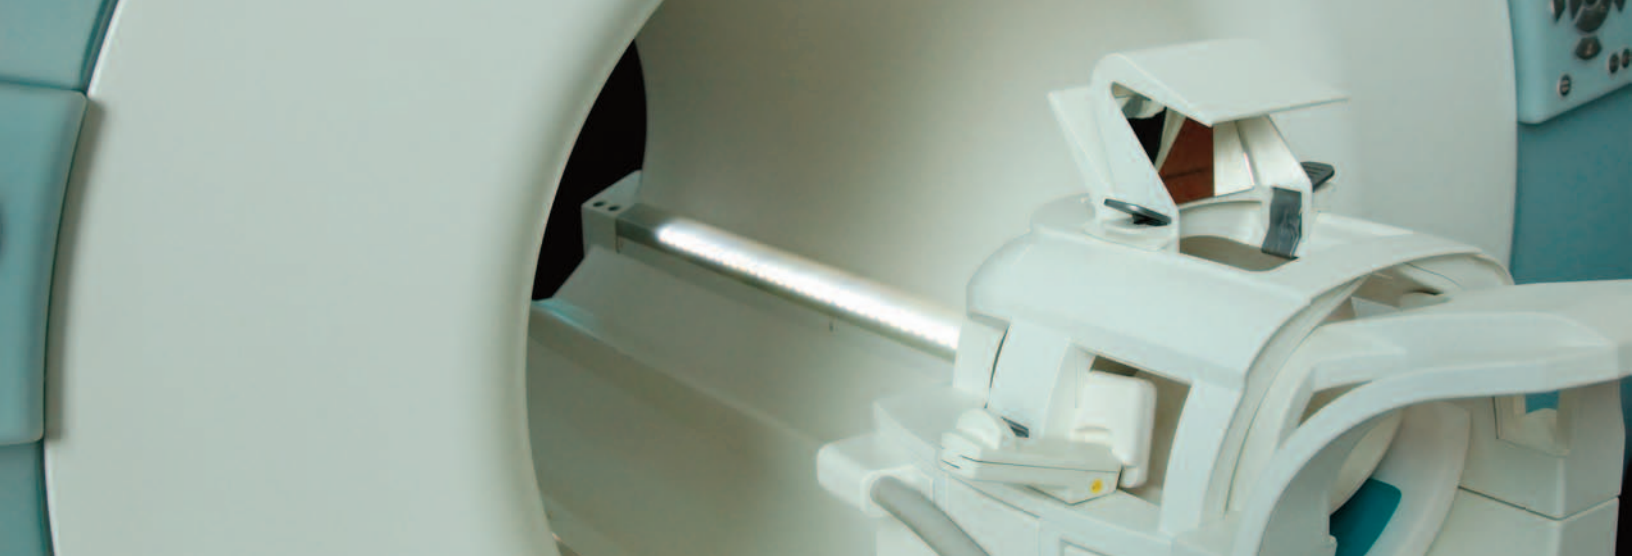
Torque forces run parallel to the translational force. Both are associated with ferromagnetic materials and the static field generated by an MRI machine. Attracted objects react by aligning parallel to the magnetic lines of force being generated by the MRI machine. The center of the MRI-generated field has the highest torque force, creating a serious exposure for all contraindicated items and MRI-conditional items in the MRI suite, depending on the tesla rating of the MRI. This effect has created life-threatening conditions for patients with some medical implants.
