# MAGNETIC RESONANCE IMAGING HAZARDS AND SAFETY GUIDELINES

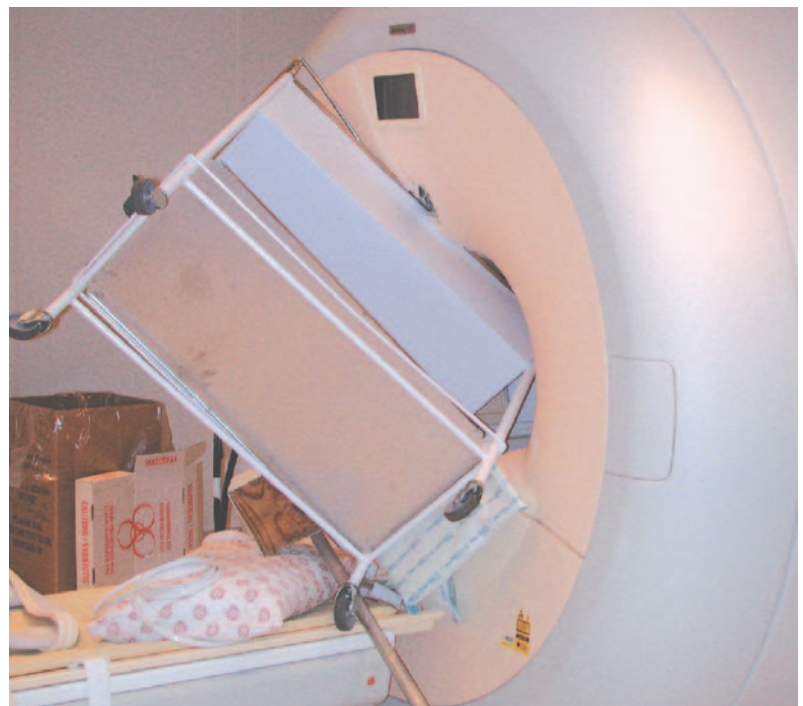
A hairpin or paper clip within the 5-10 gauss line range could reach a velocity of 40 mph and will be attracted to the center of the MRI generated field (*x, y and z axis*) where the lines of force are equal.
